SAUGUS RIVER BASIN  
SAUGUS, MASSACHUSETTS

GRISWOLD POND DAM  
MA 00292

**PHASE I INSPECTION REPORT  
NATIONAL DAM INSPECTION PROGRAM**

OCTOBER 1979

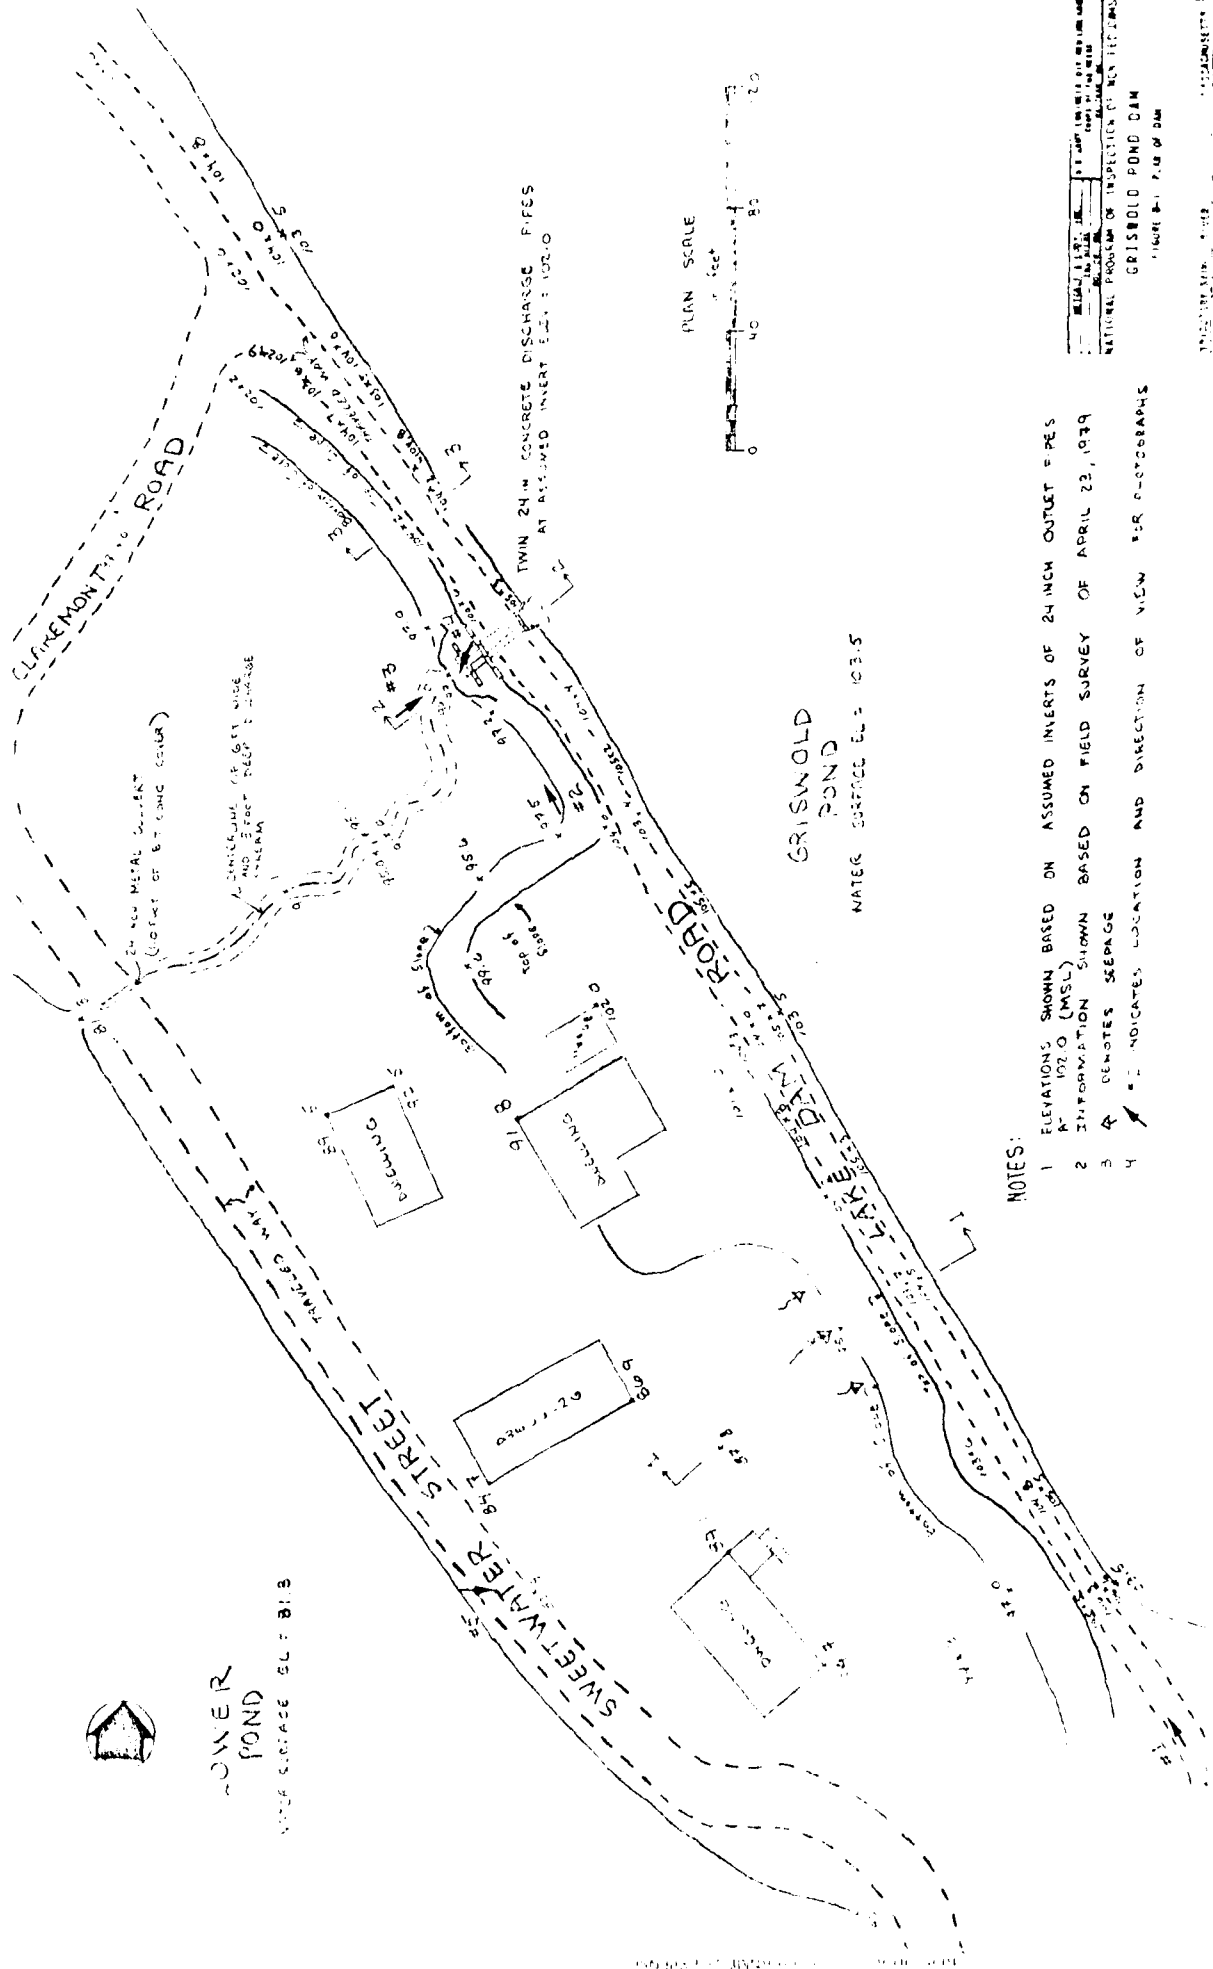
WATER LEVEL TO-DAY 6" BELOW WALL  
AT CREST OF SPILLWAY - EROSION OF LAKE DAM ROAD, POND  
SIDE 10' x 6' INTO ROAD / THIS SPOT 90 FT. NORTH OF SPILLWAY  
4 3FT. DEEP

HOLE IN EDGE OF ROAD SHOULD BE FILLED  
WITH ROCK FILL (INFORMED TOWN ENGINEER HE  
SAYS HE WILL HAVE PUBLIC WORKS MAKE TEMPOR.  
REPAIR TO WASHOUT.)  
(IMPORTANT ONLY AS MINOR FLOOD CONTROL)
